**AN ASSESSMENT OF
ABANDONED MINES IN
NORTHERN SASKATCHEWAN
(YEAR 3)**

MAY, 2003

**PREPARED FOR:
SASKATCHEWAN ENVIRONMENT**

Prepared by: Clifton Associates Ltd.
on behalf of
P.A.N.S. Joint Venture

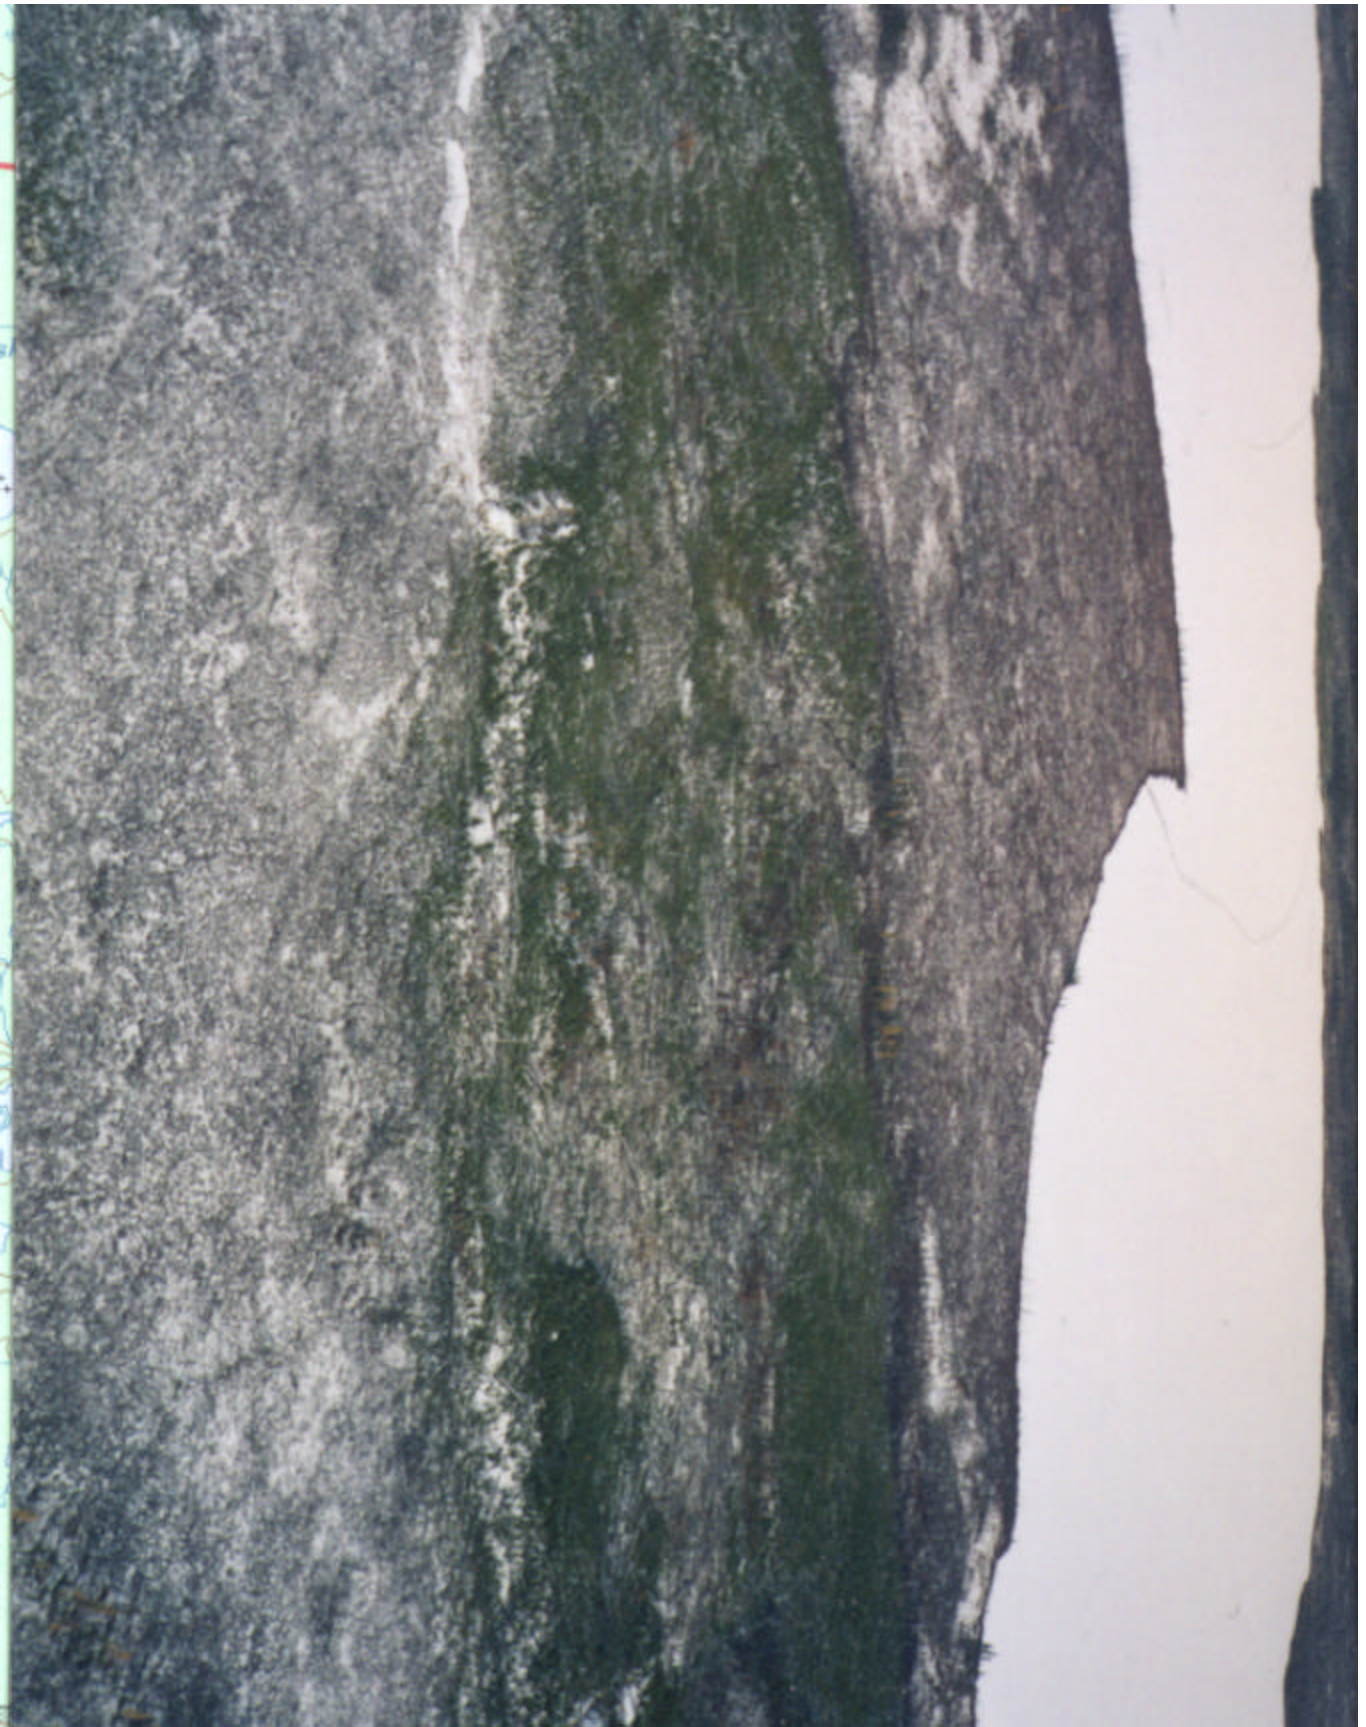
Photograph 6.32-1. Otonadah Lake Copper Showing-Aerial View-October 23, 2002.

An overflight (during the Year 3 program) of the site revealed two large trenches on the south side of a broad outcrop ridge situated about 400m south of Otonadah Lake. Several years ago the area was burned by a forest fire, resulting in heavy deadfall that makes for slow and dangerous walking. A ground inspection of the site should be completed to locate and assess the condition of the trenches and exploration shaft. Float aircraft, landing on Otonadah Lake, may be the best means of access to the site.

The primary follow-up work should be a further attempt to locate the reported 28 m deep shaft and examine the large trenches to determine if there are conditions that pose a public safety and/or environmental hazard.

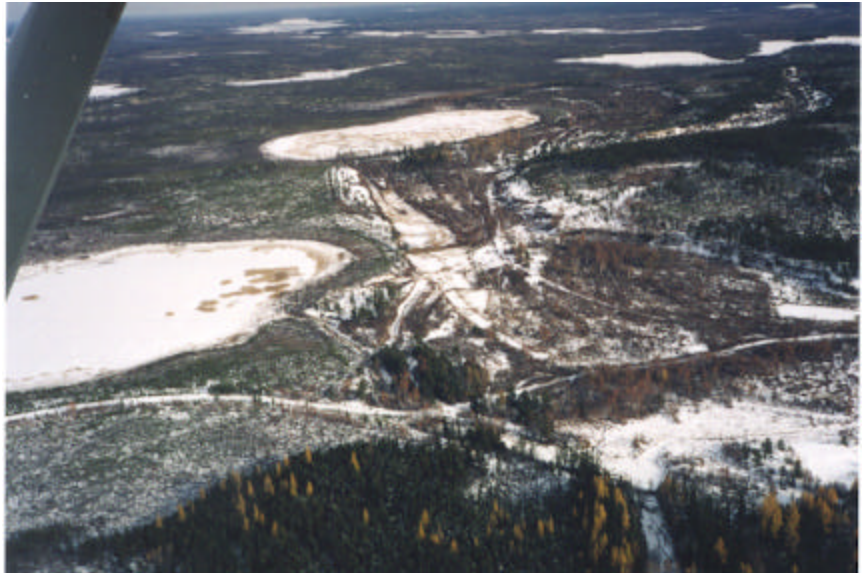
No open workings were observed. It appears that the site has been reclaimed.

No public safety hazards were observed.

Photograph 6.33-1. HBM & S Flux Pit-Aerial View-October 23, 2002.

The site does not pose a public safety risk. Consideration should be given to determining whether a drag-line was buried on site, and whether it poses an environmental risk.

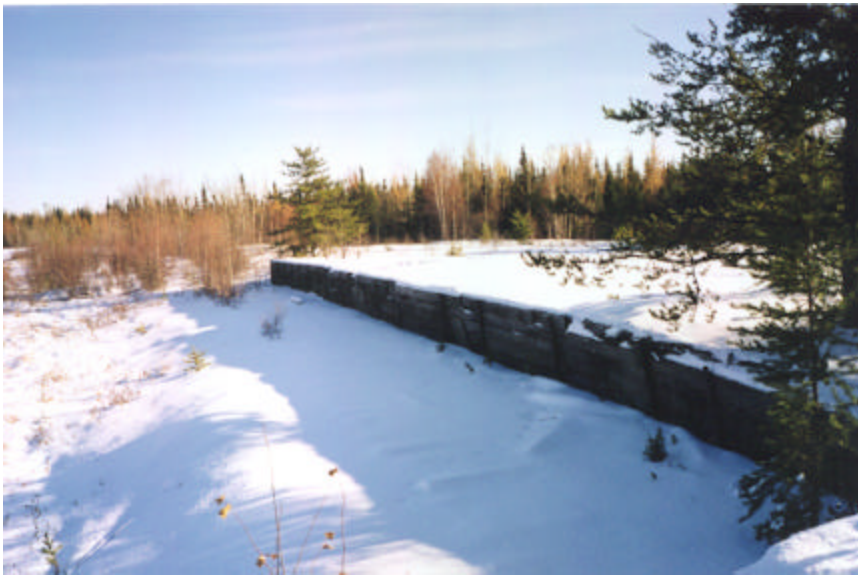
No buildings or ruins were observed. A wood timber retaining wall remains in place at the loading pad. The wall is about 30 m long and 1.5 m high. The pad is comprised of sand and fine-gravel.

Photograph 6.33-2. HBM & S Flux Pit-Wood Timber Retaining Wall at Loading Pad-October 29, 2002.

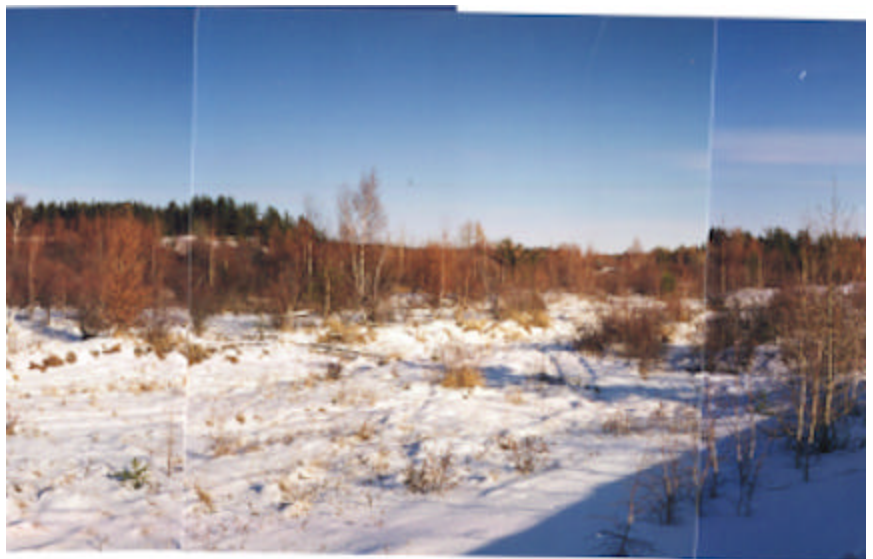
A minor amount of debris was observed and included: a length of bent steel rail (railroad track), some scrap lumber, and 15 railway cross-ties. The cross-ties appear to be what remains of a length of rail track near the loading pad. The debris does not appear to present a public safety or environmental hazard.

Photograph 6.33-3. HBM & S Flux Pit-Panoramic View From Loading Pad Looking Northeast-October 29, 2002.
